Final Five-Year Review Technical Memorandum

Second Five-Year Review Report
for
Parker Landfill Superfund Site
Town of Lyndonville
Caledonia County, Vermont

September 2009

United States Environmental Protection Agency
Region 1
Boston, Massachusetts

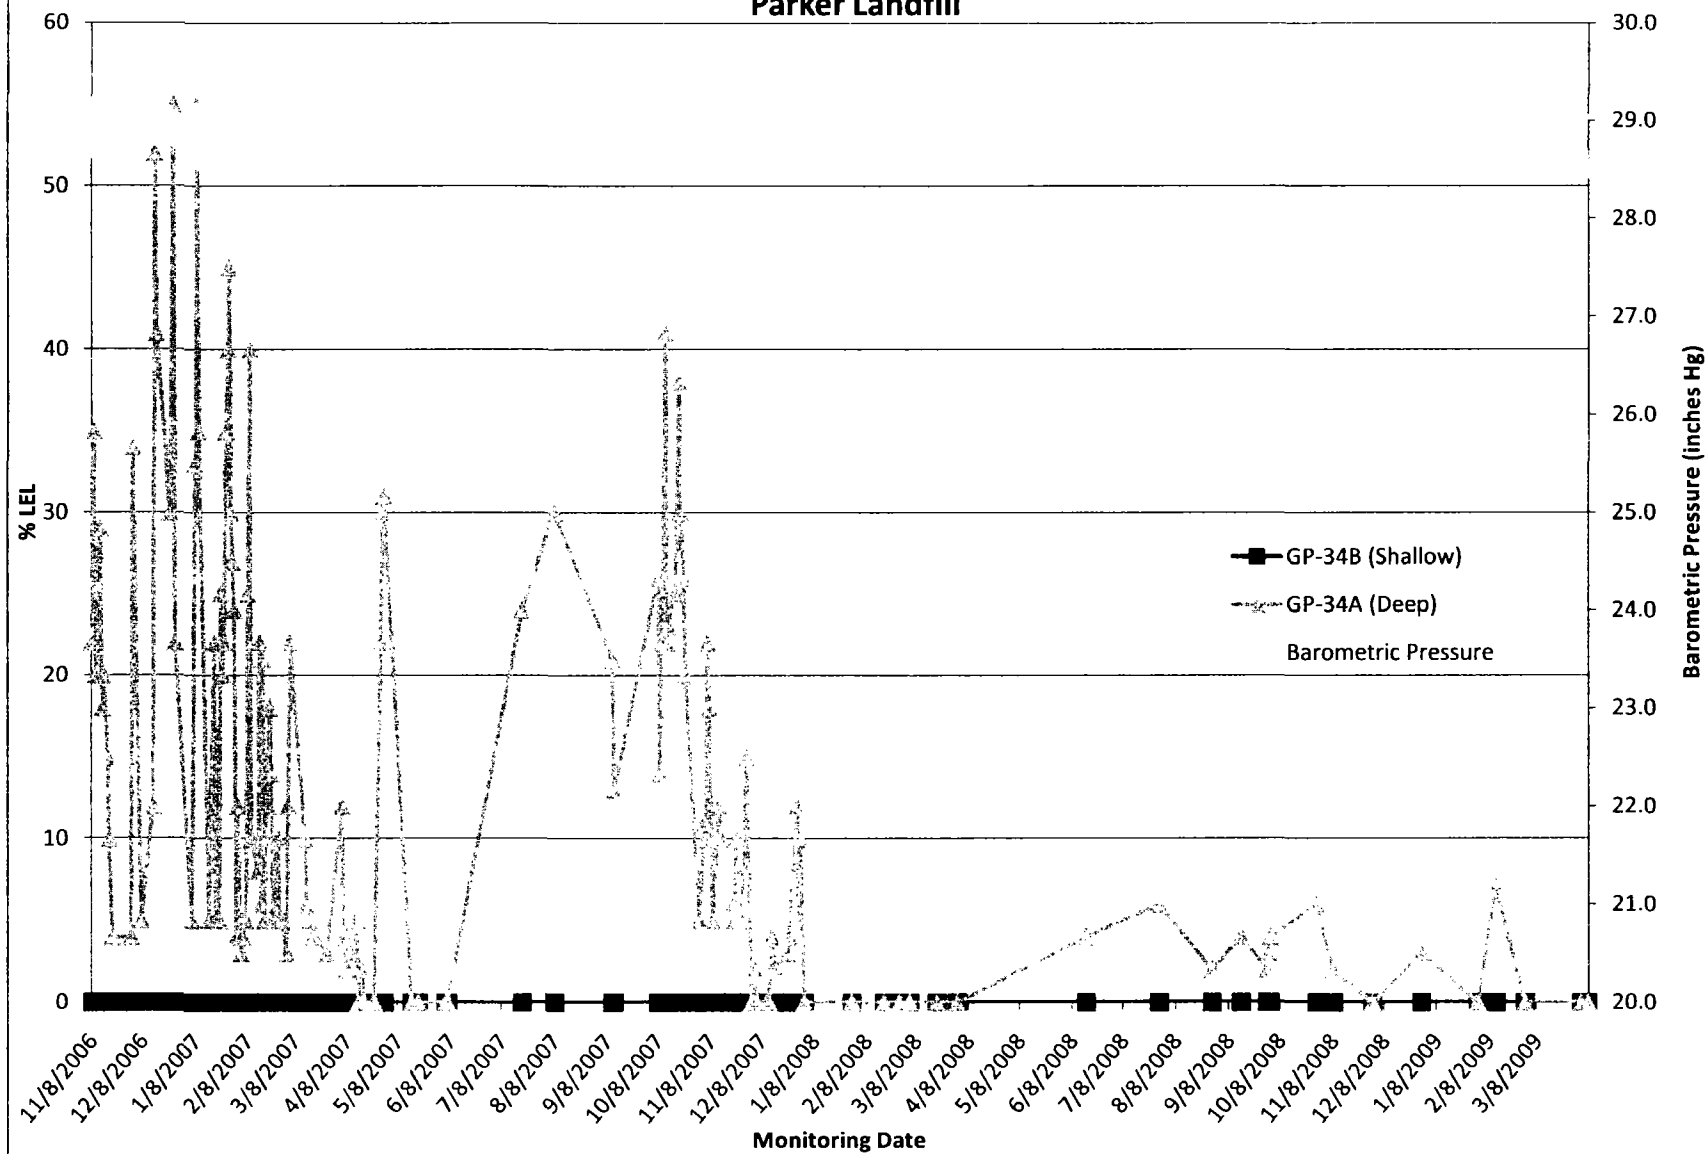
Figure 6. Gas Probe Monitoring for GP-34 Cluster - November 2006 to April 2009

During the last five-year review period (2001 to 2004), data was presented for gas probes GP-21B (shallow) and GP-21A (deep), showing a significant decrease over that period from the highest methane concentrations (as percent LEL) of 250 and 74 for the deep and shallow zones, respectively. In response to the 2004 five-year review report recommendations for further monitoring and delineation of the elevated methane concentrations, additional probes were installed in October 2004 and August 2006, including GP-34A and B and GP-35 located downgradient of the GP-21 cluster.

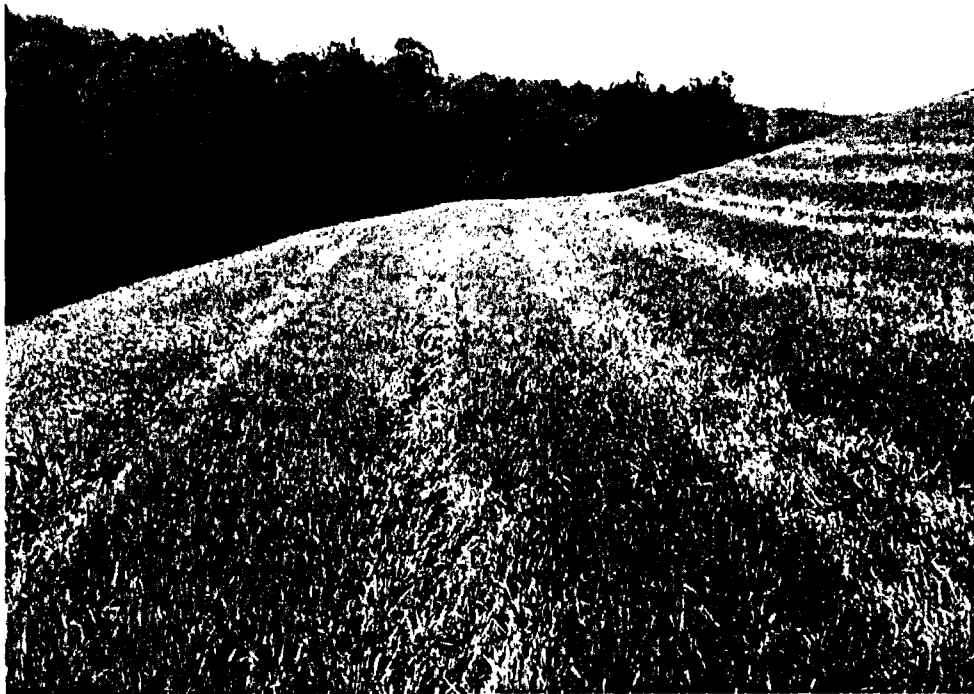
- The slope benches and other drainage ditches were in good condition with no signs of erosion, undermining or bypass.
- The two gabion-lined downcomers, or letdown channels, on the SWDA cap were in good condition with no evident material degradation, erosion, undercutting, or obstructions, with the exception of an area of settlement in Downcomer No. 2. This settlement area has been monitored since the last five-year review inspection through surveying of five points along the settled area. Representatives from Fairbanks Scales reported that based on monitoring of settlement, no repairs have been warranted. If further settlement occurs in the future that could threaten the integrity of the cap, repairs should be conducted. In addition, slight vegetative growth was noted in Downcomer No. 2. However, the amount of vegetation is not sufficient to impede flow.

Photo 2. Landfill bench, looking south

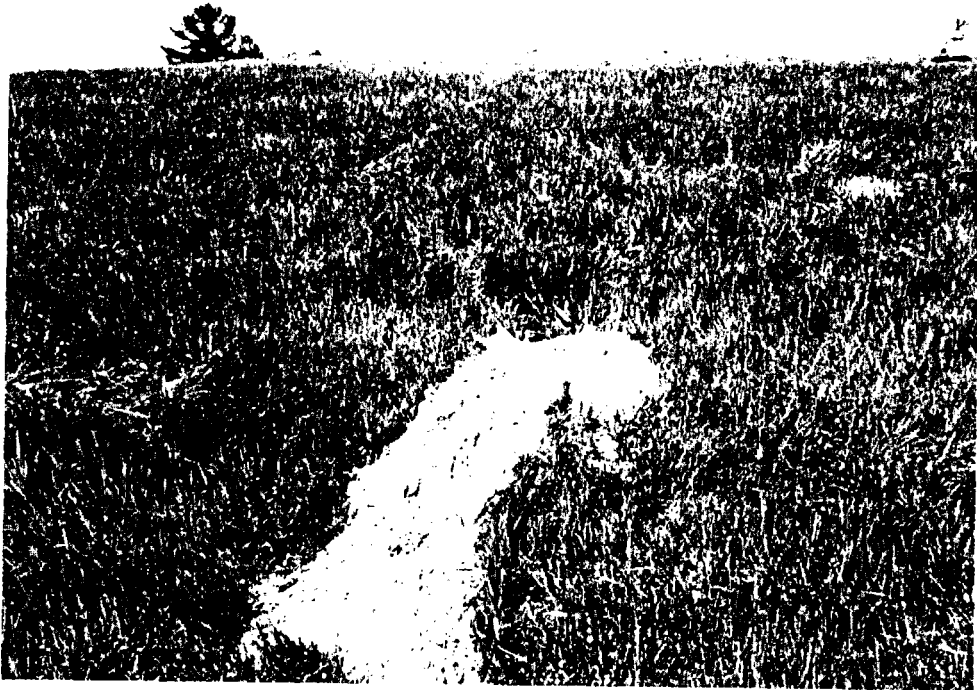
- The surfaces of the SWDA landfill cap and the IWS-3 cap were in good condition with no signs of erosion, holes, cracks or bulging.
- Apparent animal burrows were observed on the steep slope of the SWDA in several locations, including downslope of W-11, nearby W-15, and W-17. The animal should be removed and the hole and erosion repaired in order to prevent possible undermining of the SWDA cap.

Photo 3. Woodchuck in hole near W-11 (shown in upper right).

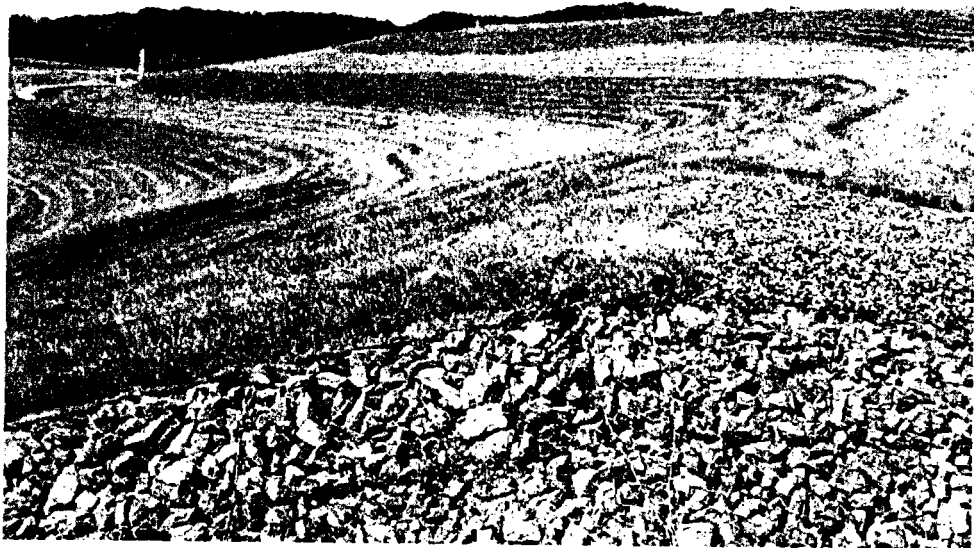
Photo 4. Maintained landfill slope.

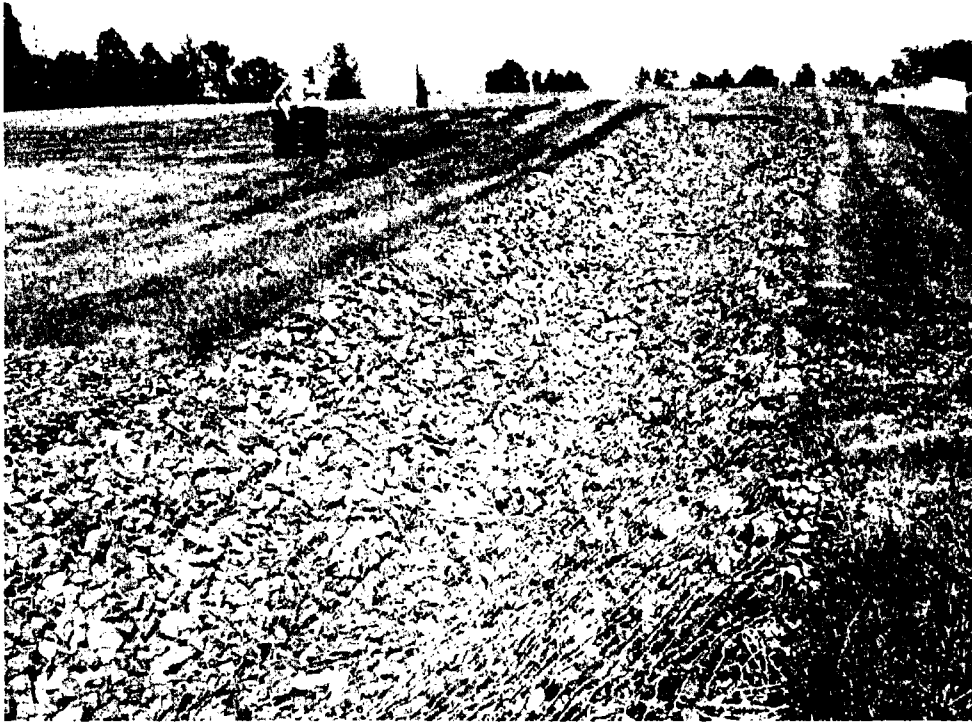
Photo 5. Downcomber # 2.

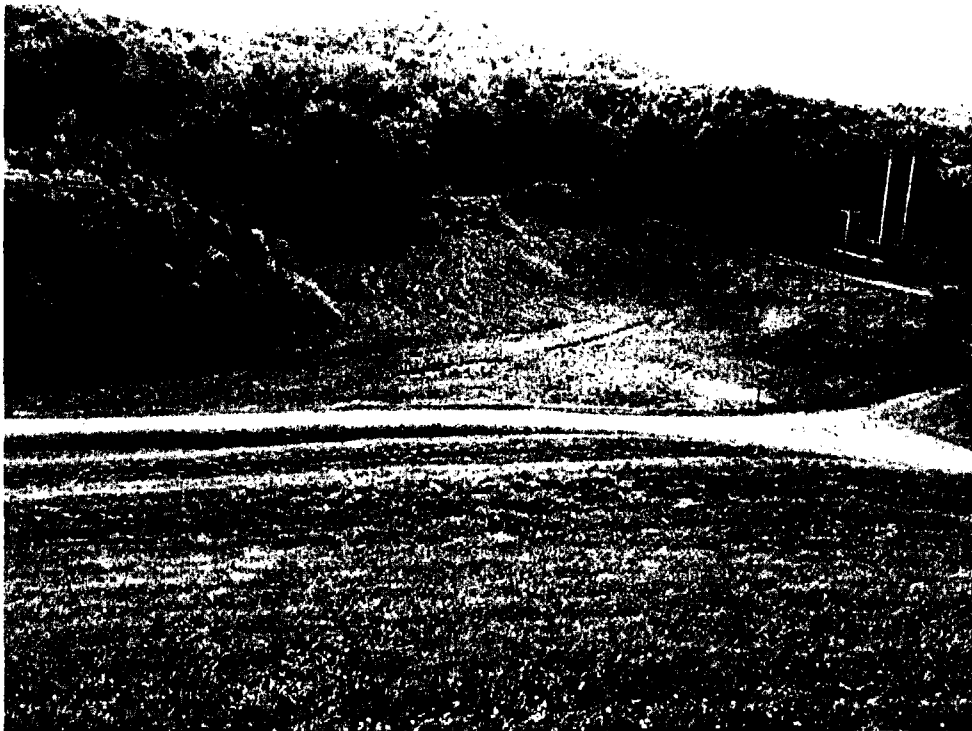
- The PRB and source area monitoring wells appeared to be in good condition, based on visual observation. No wells were opened during the site visit.
- Several empty drums were stacked in a pile along the utility easement off Brown Farm Road. Most of these drums appeared to be old and unusable. URS stated that the drums had been stored there since the last BNA injection. URS has plans to remove the drums from the Site during fall 2009.
- The BNA system wells appeared to be in good condition, based on visual observation. No wells were opened during the site visit.
- The wetland compensation areas appear to be functioning as designed.

Photo 6. PRB monitoring wells.

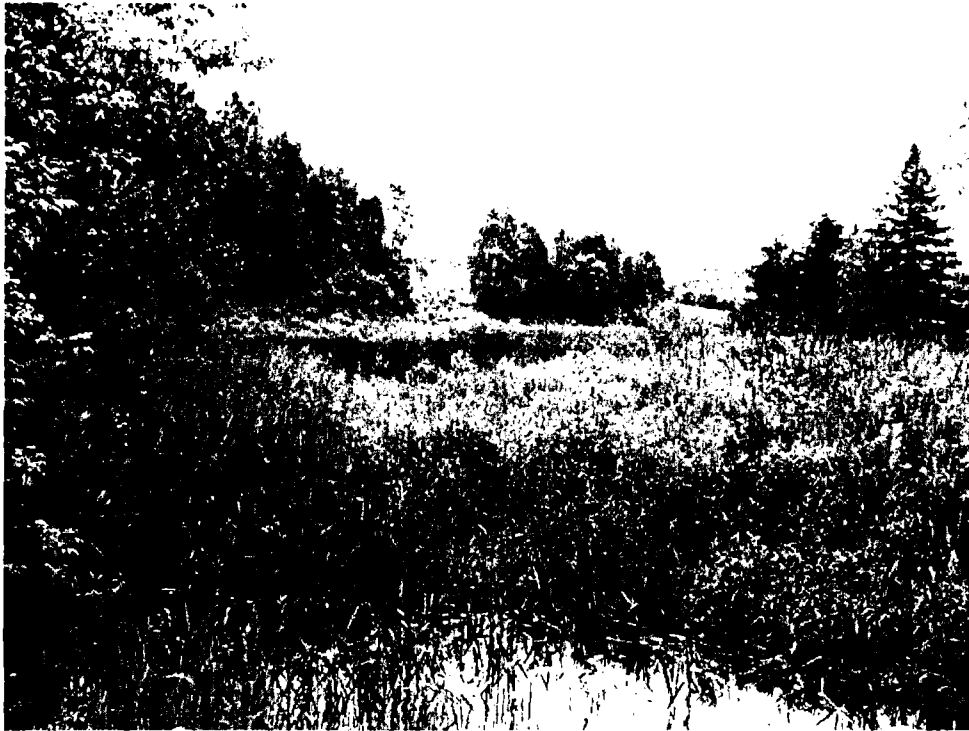
Photo 8. Constructed wetland

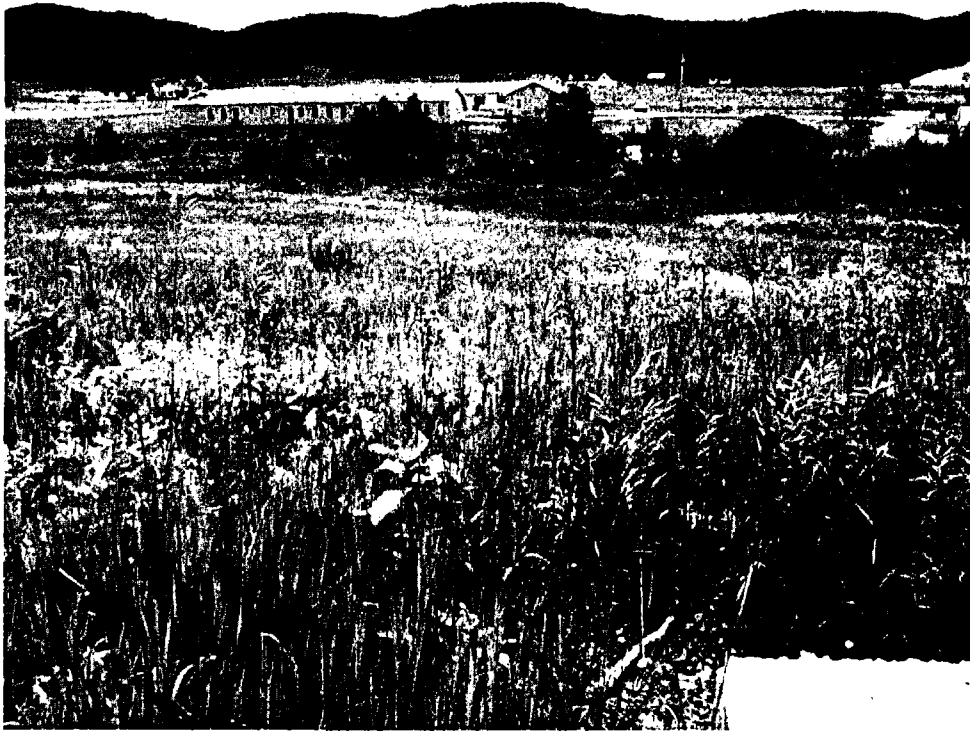
Assisted living facility (new homes - some have basements) built down gradient of site on Brown Farm Road**VI. GENERAL SITE CONDITIONS****A. Roads**☒ Applicable

Photo 9. Looking at new development along Brown Farm Road from BNA well B146B.

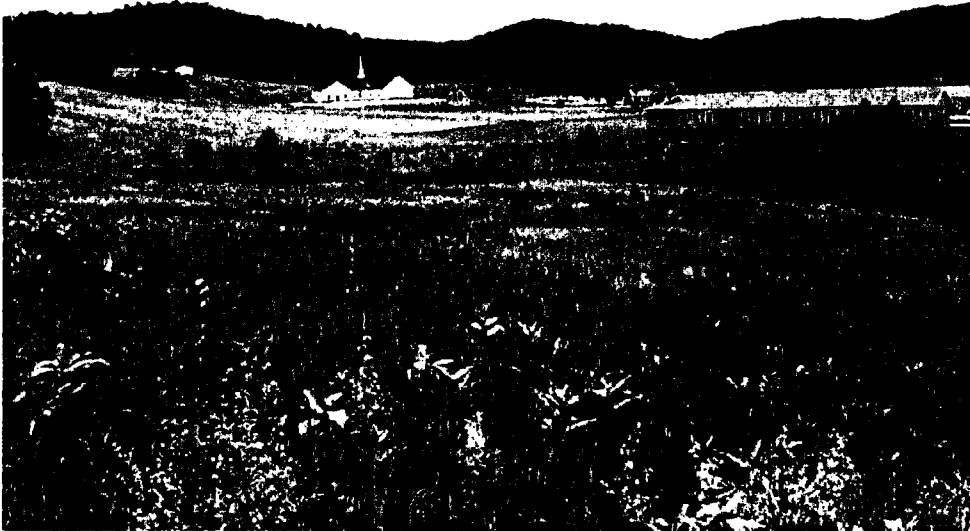
Photo 10. Other structures downgradient of BNA area.
